Rail Accident Investigation Branch

Rail Accident Report

Extensive track damage between Ferryside and Llangennech, Carmarthenshire 30 October 2017

Report 17/2018
October 2018

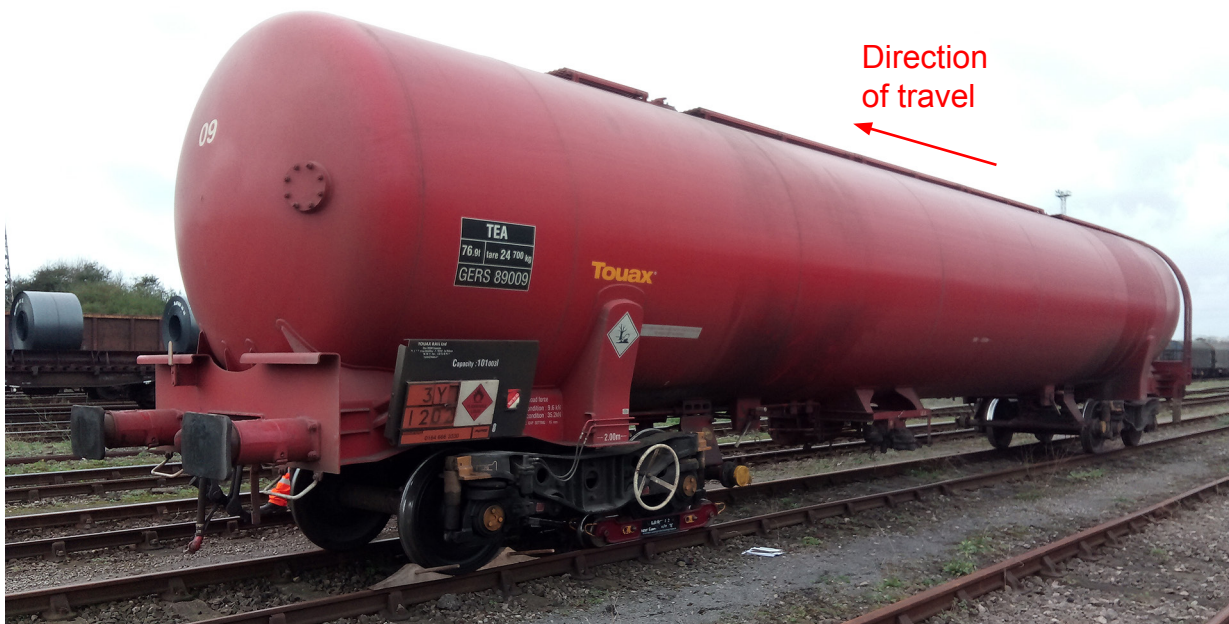
Figure 3: Wagon GERS89009 at Margam after the accident (courtesy DB Cargo)

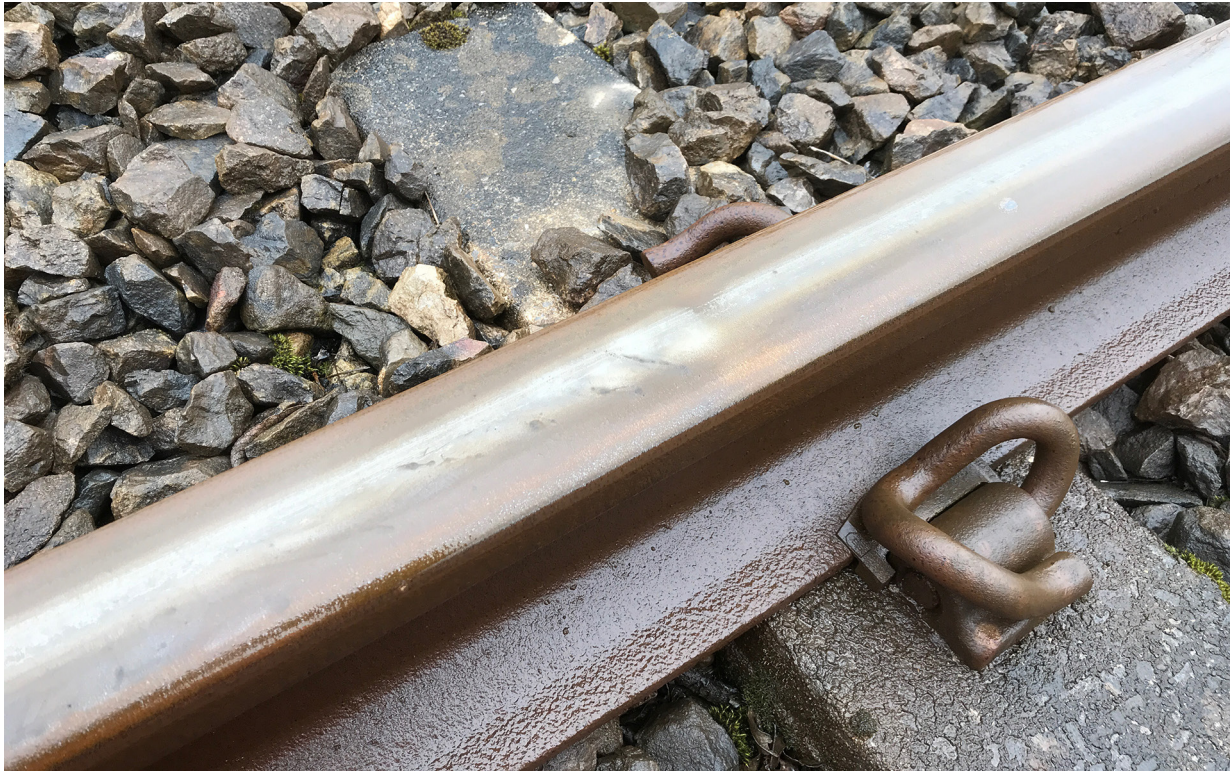
- 33 At 06:32 hrs, the train passed through a 20 mph (32 km/h) permanent speed restriction, starting 40.5 miles (65.2 km) from Robeston, shortly after passing Carmarthen Junction. After the accident track maintenance staff found the first signs of damage on the rail head at 41.6 miles (67.0 km) (figure 4). This damage continued along the route of the train and was consistent with impacts from the wheel flats that were subsequently discovered on the wheels of wagon GERS89009.

Figure 4: Rail head damage (six foot rail) 43.2 miles (69.5 km) from Robeston, still visible in April 2018

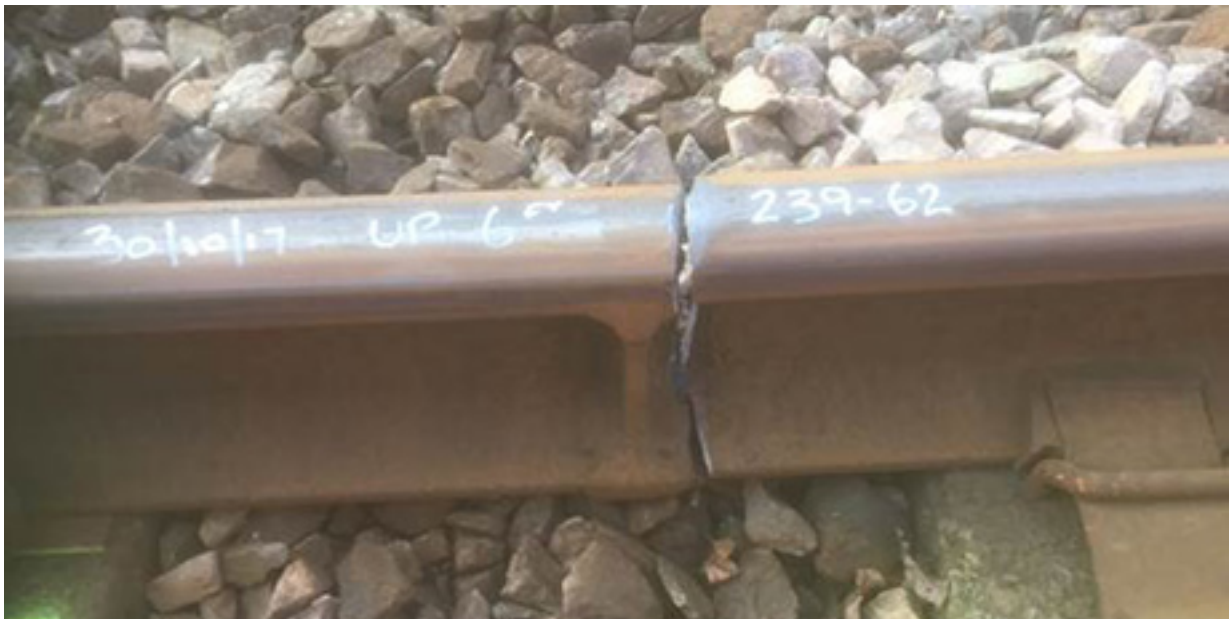
- 34 The first broken rail occurred at 44.9 miles (72.2 km), adjacent to a welded rail joint (figure 5). There are no track circuits at this location, so the fault was not apparent to the signaller. Train 6B13 passed this location at 06:40 hrs.

Figure 5: Broken weld 44.9 miles (72.2 km) from Robeston (courtesy Network Rail)

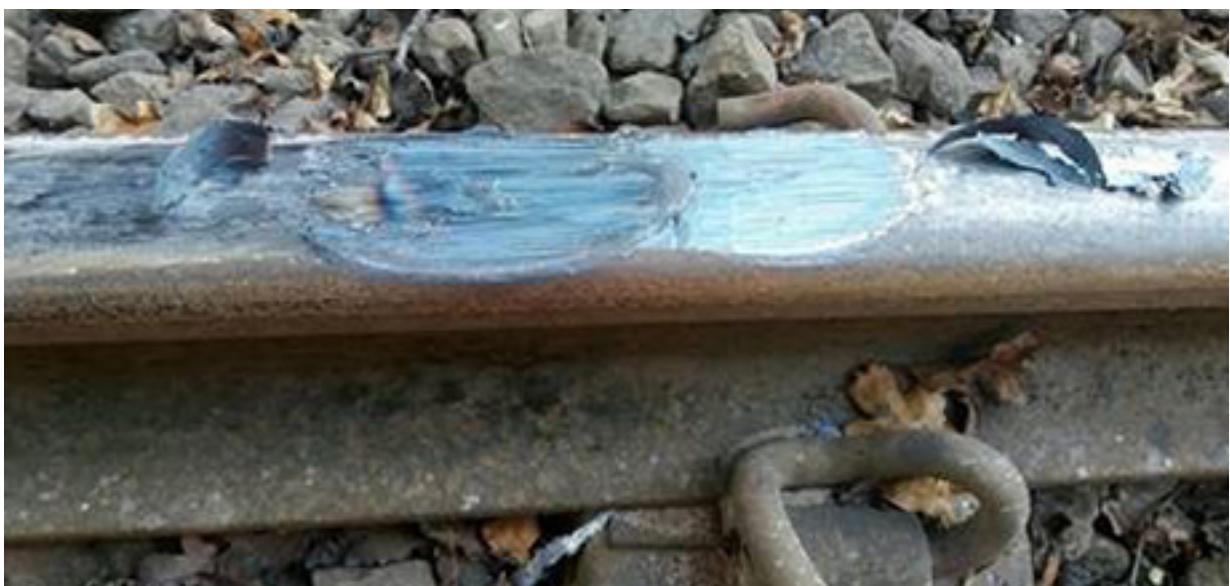
Figure 7: Damage to the rail head 67.2 miles (108.1 km) from Robeston (courtesy Network Rail)

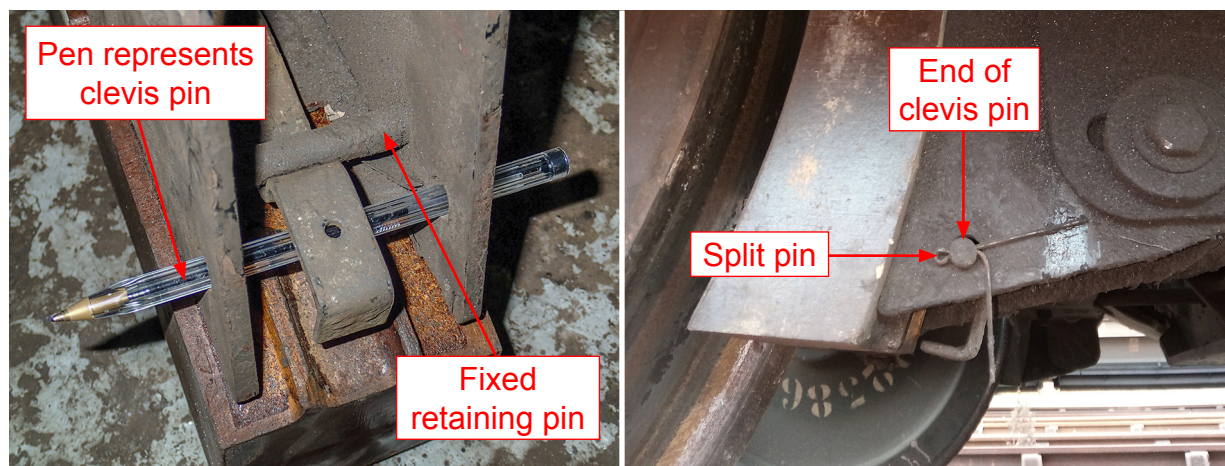
Figure 13: Arrangement of brake block, block holder, key and clevis pin; the right-hand image shows wheel position 1 on the trailing bogie of wagon GERS89009 after the accident (courtesy DB Cargo)

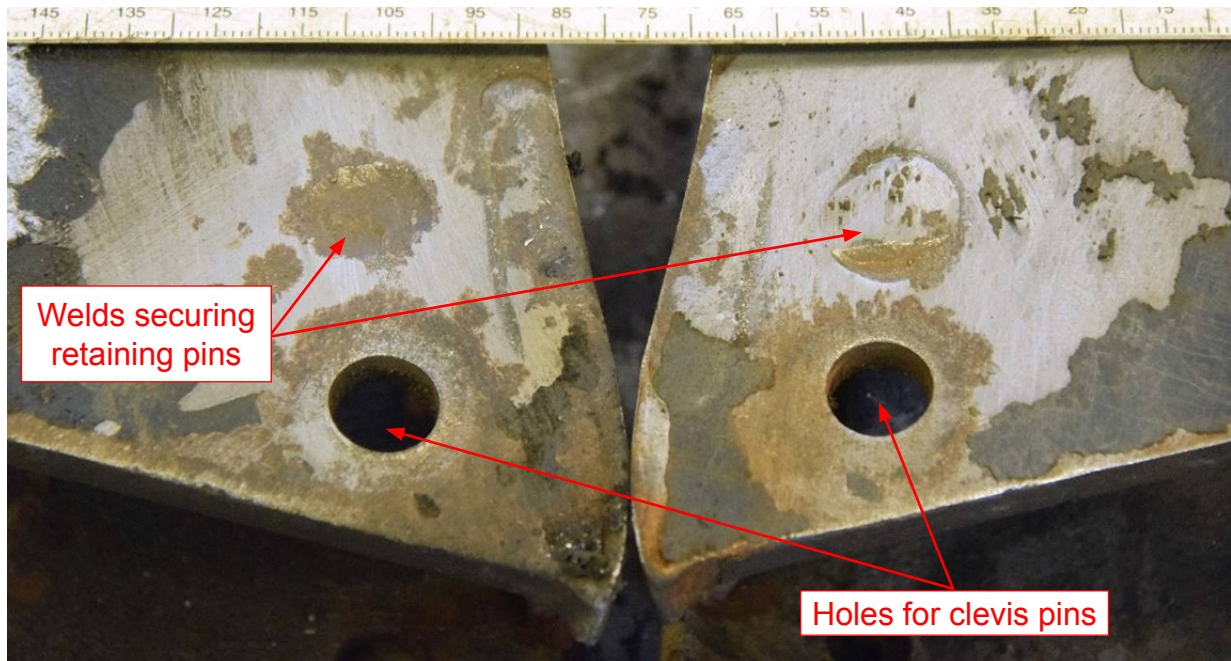
Figure 14: Outer faces of block holders from wheel positions 7 and 8, partially cleaned (courtesy Serco Rail Technical Services)

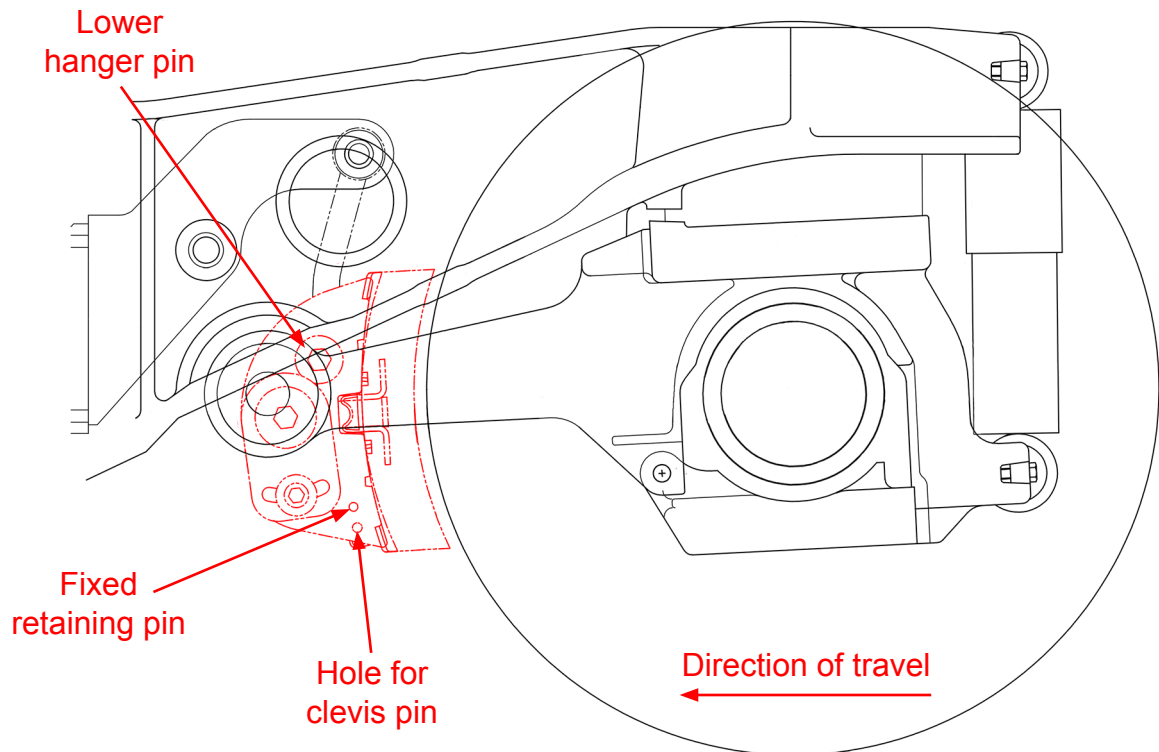
- 61 The lower hanger pin at wheel position 6 had sheared (paragraph D10, appendix D), allowing the end of the master brake beam to break free. The associated block holder was pulled apart and the head of the hanger pin, together with part of the brake block holder, has not been found.

Figure 15: View of bogie at wheel position 6 (block holder and brake block shown in red) (based on a drawing supplied by Wabtec Faiveley)

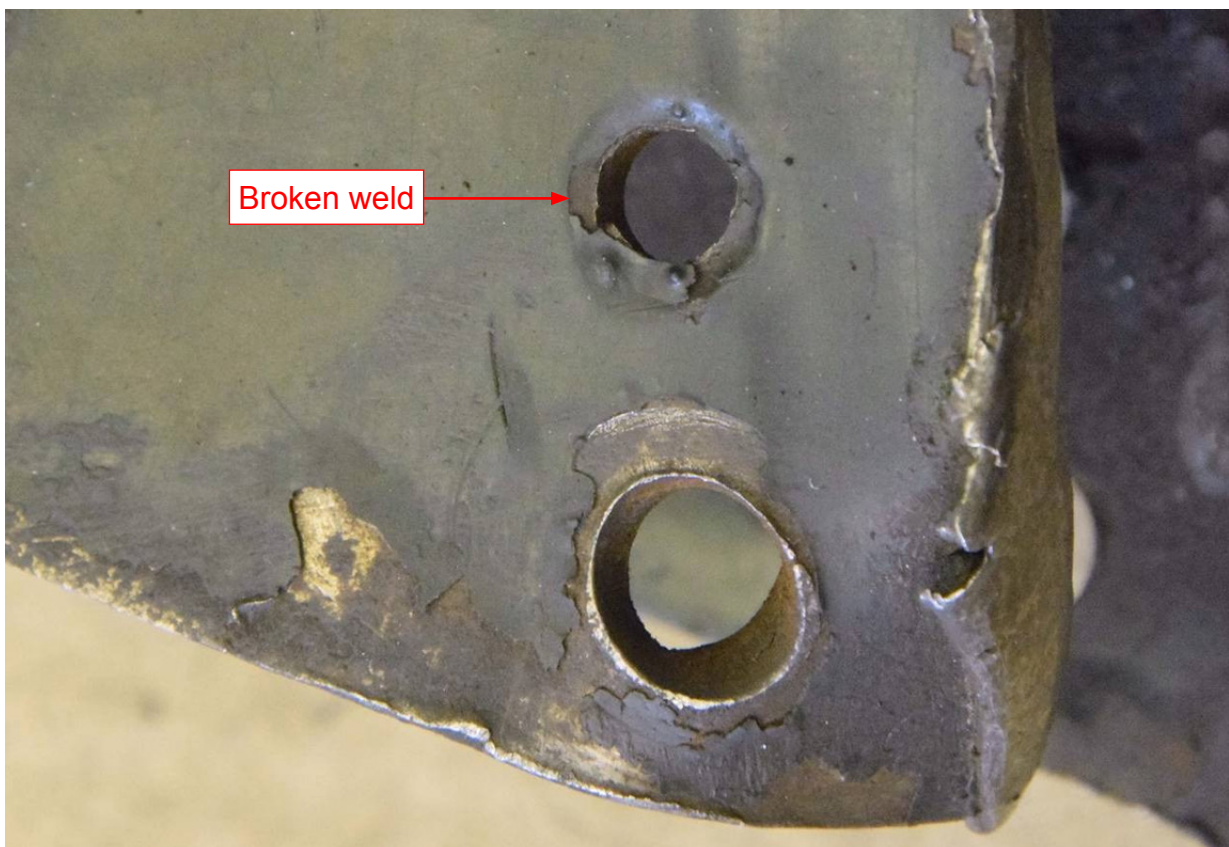
81 While the block holder from wheel position 6 (figure 8) was destroyed, accounting for the loss of that retaining pin, the block holder from wheel position 5 remained intact. The welds that secured the pin in position had failed (compare figure 16 with figure 14).

Figure 16: Inside corner of block holder from wheel position 5 (courtesy Serco Rail Technical Services)

82 The block holder from wheel position 5 connected the brake hanger to the master brake beam, so it was subjected to the forces necessary to drag the brake beam along under the train after the left-hand end had broken free (paragraph D2, appendix D), as well as to the impact loading due to the wheel flats (paragraph 65). It was distorted during the accident and it is therefore possible that loss of the retaining pin was a consequence of the damage to the bogie.

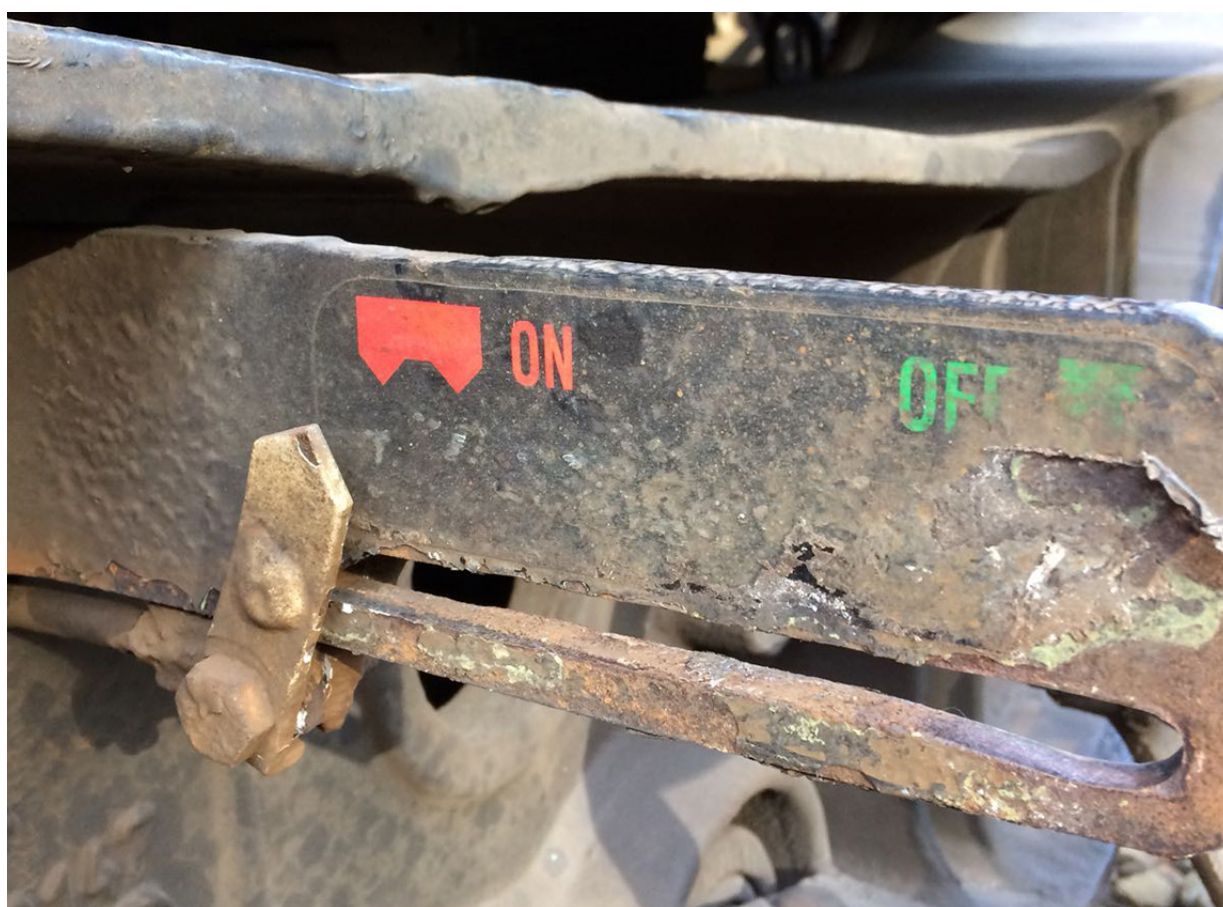
Figure 17: Handbrake indicator on wagon GERS89009 after the accident (courtesy Network Rail)

85 After the accident, the handbrake indicator on wagon GERS89009 was found in the 'on' position (figure 17). Later examination of the braking system revealed that the linkage to the indicator had been extensively damaged in the accident. Examination of the remainder of the mechanism showed it to be consistent with the handbrake having been in the 'off' position. The handbrake also acts equally on both wheelsets (paragraph 53), so it is improbable that it could have caused one wheelset to lock without the other.

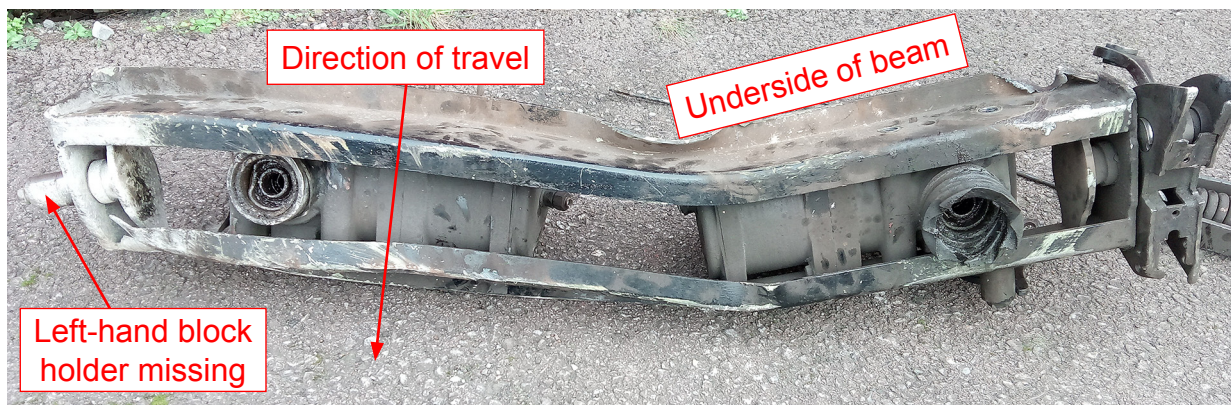
- D3 The master brake beam had bent around the middle (figure D2). The bending was consistent with the beam having come into contact with the trailing axle of the bogie while bouncing along at speed under the wagon. The left-hand block holder (wheel position 6) was missing from the end of the beam; part of it (the outer face) was later found 62.1 miles (100.0 km) from Robeston.

Figure D2: Master brake beam from bogie 2741 (courtesy DB Cargo)

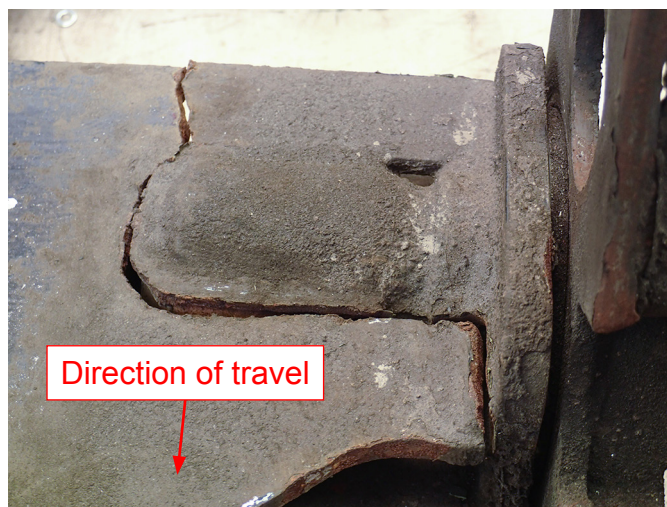
D4 The welded joint at the left-hand end of the slave brake beam was found to be cracked adjacent to the block holder (figure D3).

Figure D3: Cracking of slave brake beam at wheel position 8

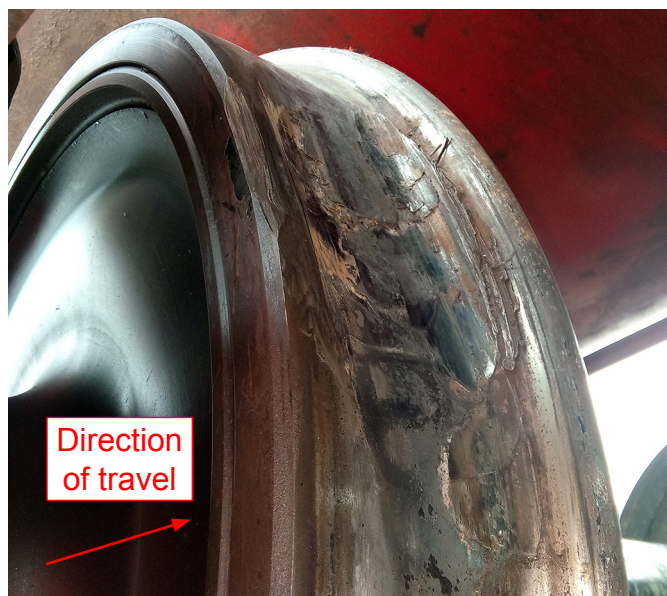
D5 The second wheelset (wheel positions 5 and 6) of bogie 2741 had wheel flats approximately 250 mm long and 10 mm deep (figure D4). The size of the flats is consistent with the wheels having slid an estimated 5 to 10 miles (8 to 16 km) while the wagon was fully laden with a 25 tonne axle load. The marks on the rail head (paragraph 33) and the broken rails over the following 22 miles (36 km) indicate that the second wheelset had started turning again approximately 42 miles (67 km) from Robeston.

Figure D4: Flat on wheel at position 5 (courtesy DB Cargo)

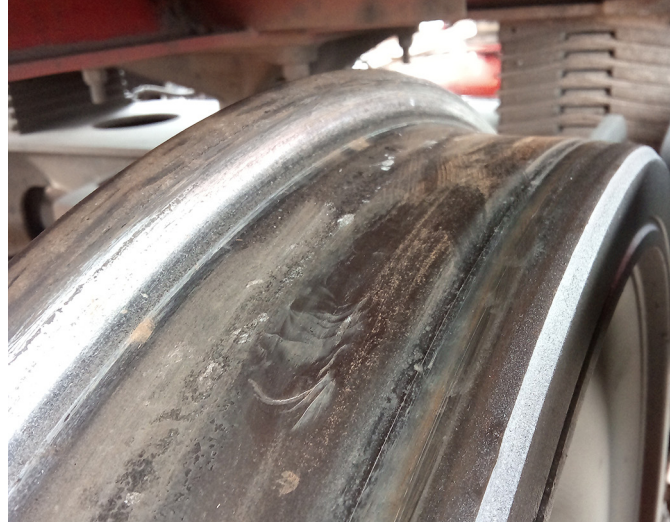
D6 DB Cargo examined the wheelsets from bogie 2741 after the accident. In addition to the severe flats on the wheels at positions 5 and 6, there was also a small flat spot on the wheel at position 8 (figure D5). This was probably pre-existing and unrelated to the accident (paragraph 89).

Figure D5: Flat on wheel at position 8 (courtesy DB Cargo)

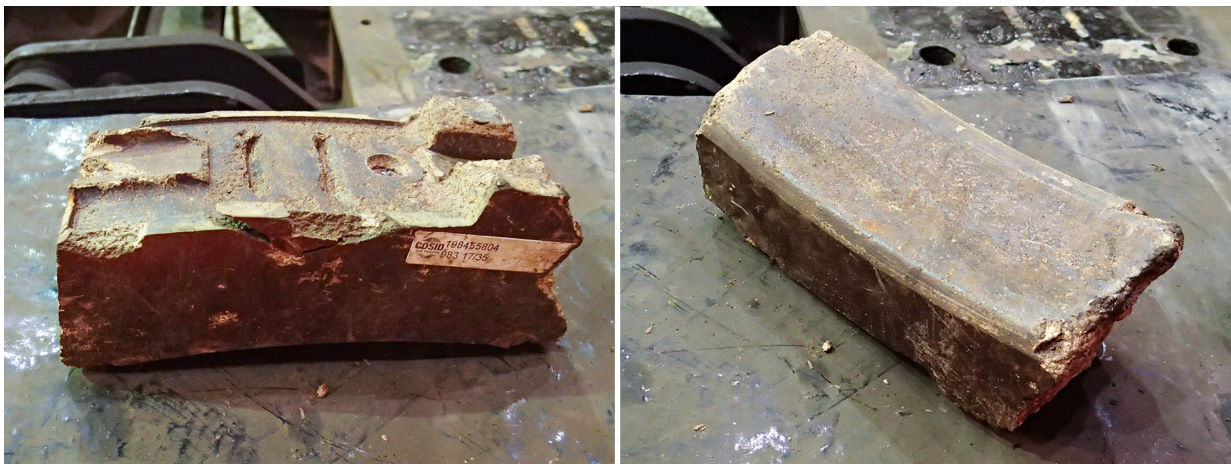
D7 The brake blocks were missing from all four wheels on bogie 2741, together with the keys and clevis pins (paragraphs 54 and 55). Part of a brake block was found 43.6 miles (70.2 km) from Robeston; this was 2.0 miles (3.2 km) after the start of damage to the rail head (paragraph 33). This was only lightly worn, indicating that it had recently been fitted to a vehicle (figure D6); the label records that it had been manufactured in the week commencing 28 August 2017. It is the same type of block as that fitted to wagon GERS89009 on 27 October 2017, which is not used on any passenger vehicles that operate in the Carmarthen area. No other brake blocks have been found that might have come from bogie 2741.

Figure D6: Brake block fragment found 4 miles (7 km) east of Carmarthen

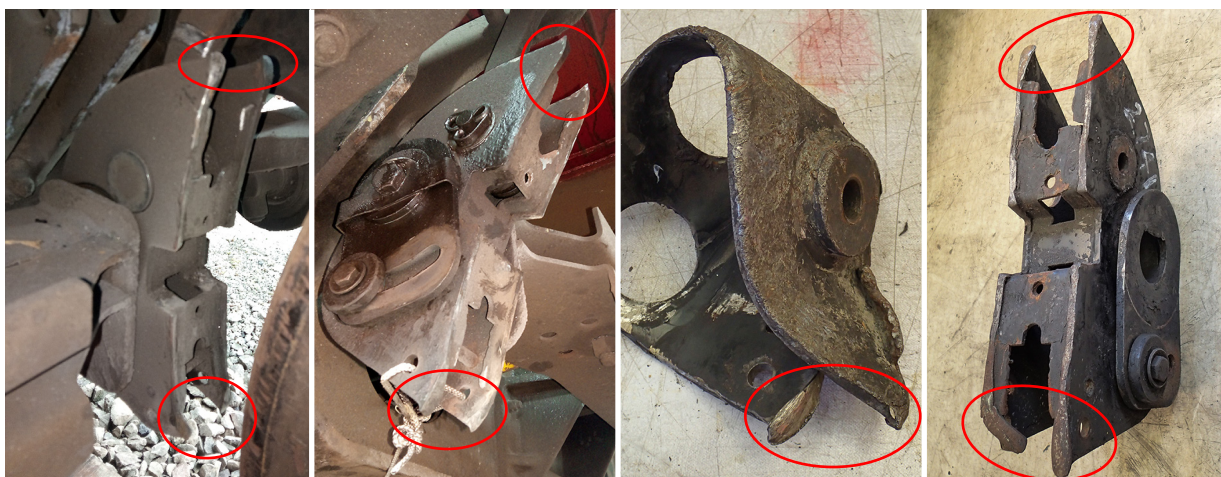
D8 The corners of all block holders from both wheelsets were worn (figure D7). This indicates that the block holders had been in contact with the rotating wheels with no brake blocks present. Measurements of the wear made by Serco indicate that the block holders from the master brake beam were more severely worn than those from the slave beam, and the bottom of each block holder was worn more than the top.

Figure D7: Brake block holders from wheel positions 8, 7 (both courtesy DB Cargo), 6 and 5 with worn corners indicated

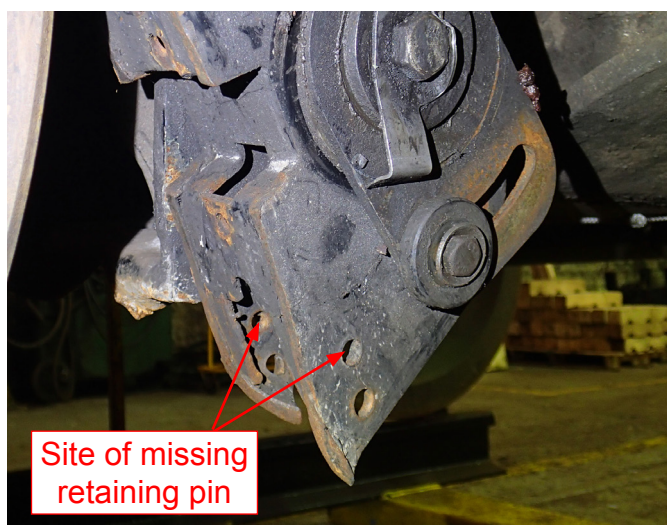
D9 The fixed retaining pins, that together with the clevis pin (figure 13) hold the brake block key in place, were missing from the damaged block holders on the second wheelset. The block holder from wheel position 6 had been torn in two, probably causing failure of the welded joints at the ends of the retaining pin. However, the retaining pin was also missing from the block holder at wheel position 5 (figure D8), which remained intact although distorted.

Figure D8: Brake block holder from wheel position 5

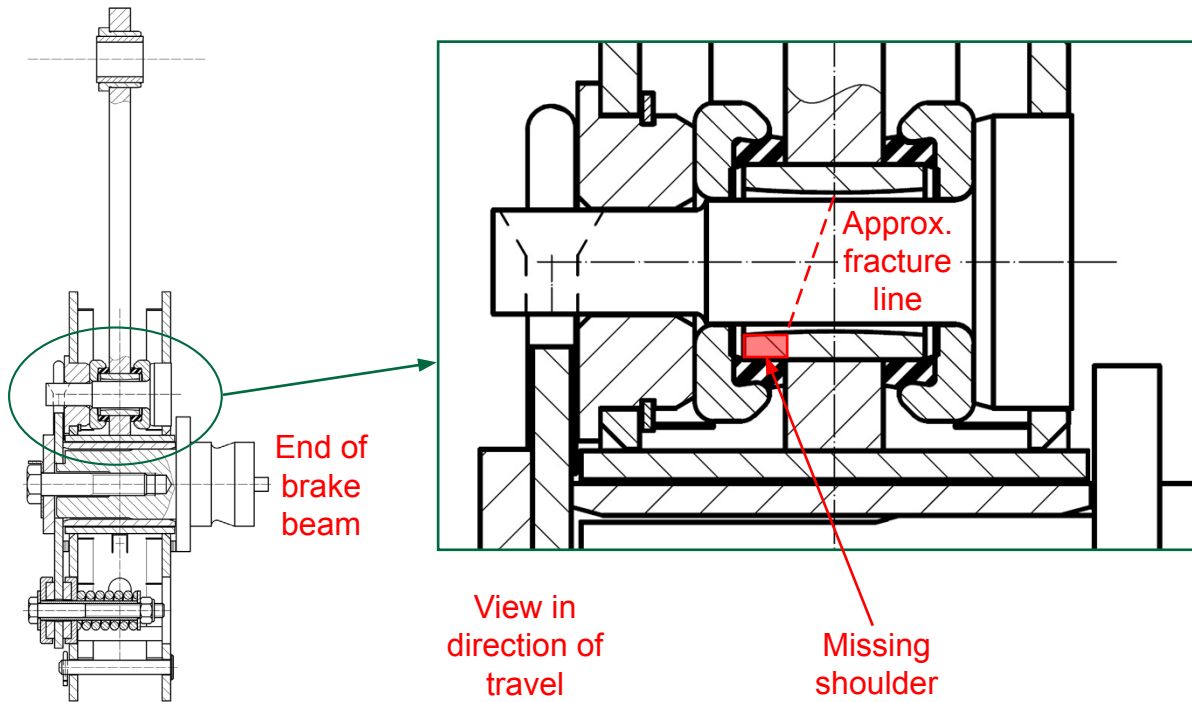
D10 The lower left-hand hanger pin (at wheel position 6) had sheared, and the corresponding shoulder of the hanger bush was damaged (figure D9). Only the outer half of the block holder has been found on the track, together with the tail of the hanger pin; the rest of the block holder and the head of the pin are missing.

Figure D9: Section through brake hanger from wheel position 6; inset showing lower hanger pin (courtesy Wabtec Faiveley)

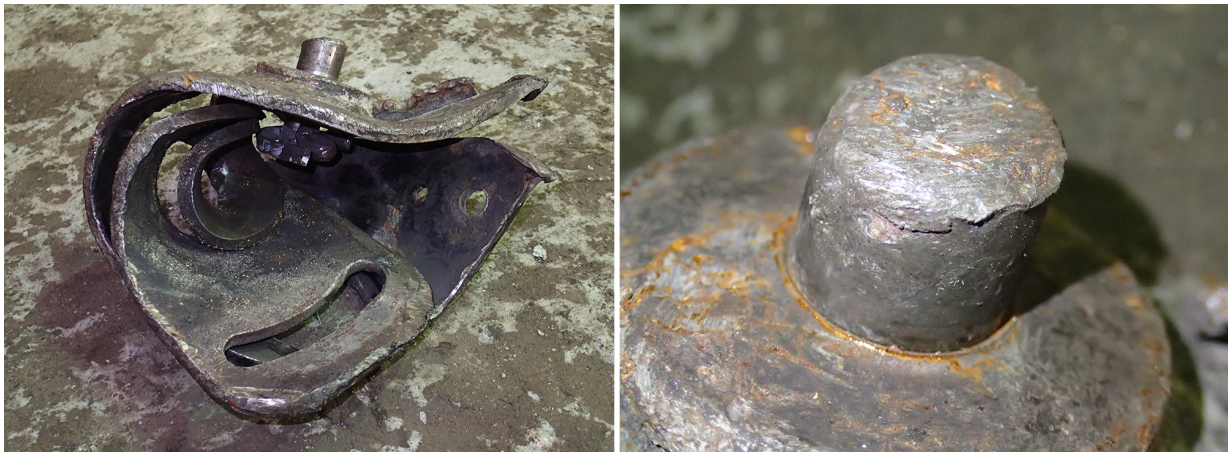
D11 Serco Rail Technical Services carried out a metallographic examination of the remains of the hanger pin. Serco concluded that, although the fracture surface of the pin was too badly damaged to determine the cause of the failure, the angled fracture (figure D10) indicated it had been overloaded in bending and shear. Conversely, failure due to fatigue would probably have resulted in a perpendicular fracture.

Figure D10: Remains of block holder from wheel position 6 and close up of fractured hanger pin

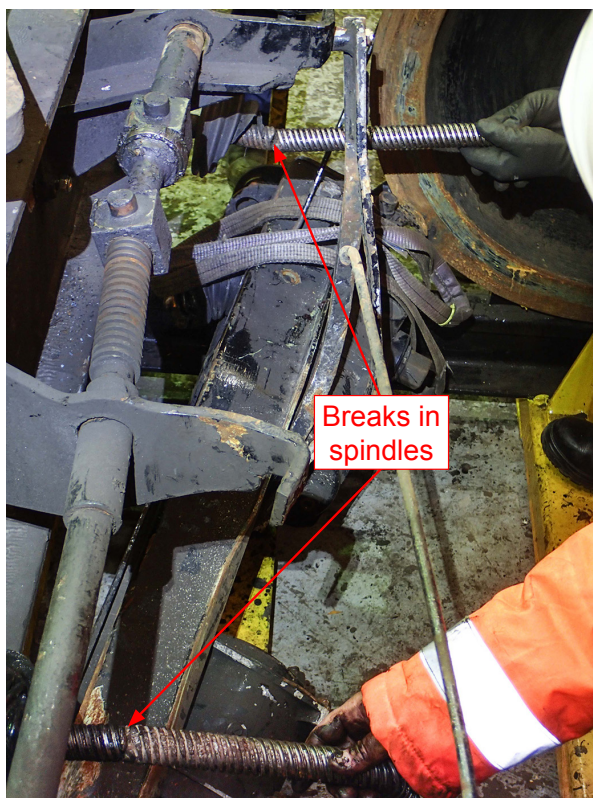
D12 The spindles connecting the brake beams had snapped, close to where the spindles project from the actuators (figure D11). Analysis of the fracture surfaces by Serco indicated that the spindles had been subject to severe reverse bending and their failure was probably due to low cycle fatigue²⁷.

Figure D11: Reconstruction of bogie 2741; the visible part of the spindles would normally be hidden within the actuators mounted on the master brake beam (the detached brake beam is visible underneath)

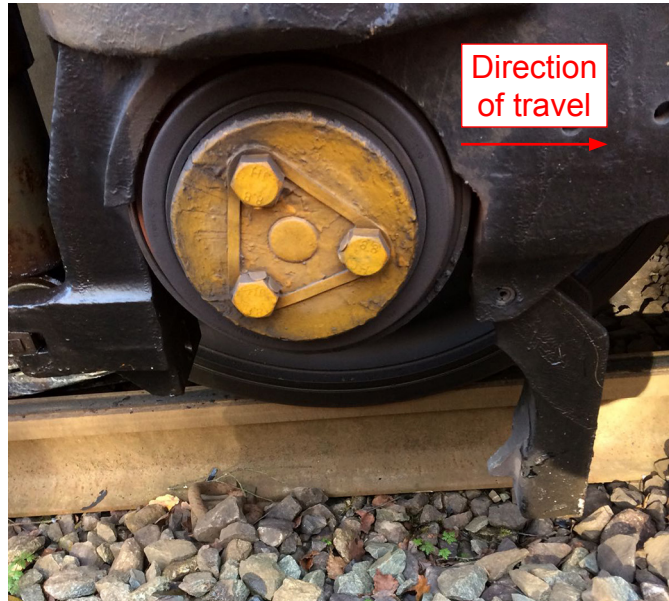
D14 The retaining bolt for the wheelset lift bracket at wheel position 5 was missing (figure D12). The bolt probably failed due to the dynamic loading caused by the wheel flats on this wheelset. The missing bolt has not been associated with any possible causal mechanism for the brake system failure on the wagon.

Figure D12: Wheelset lift bracket at wheel position 5 hanging down after the accident (courtesy Network Rail)

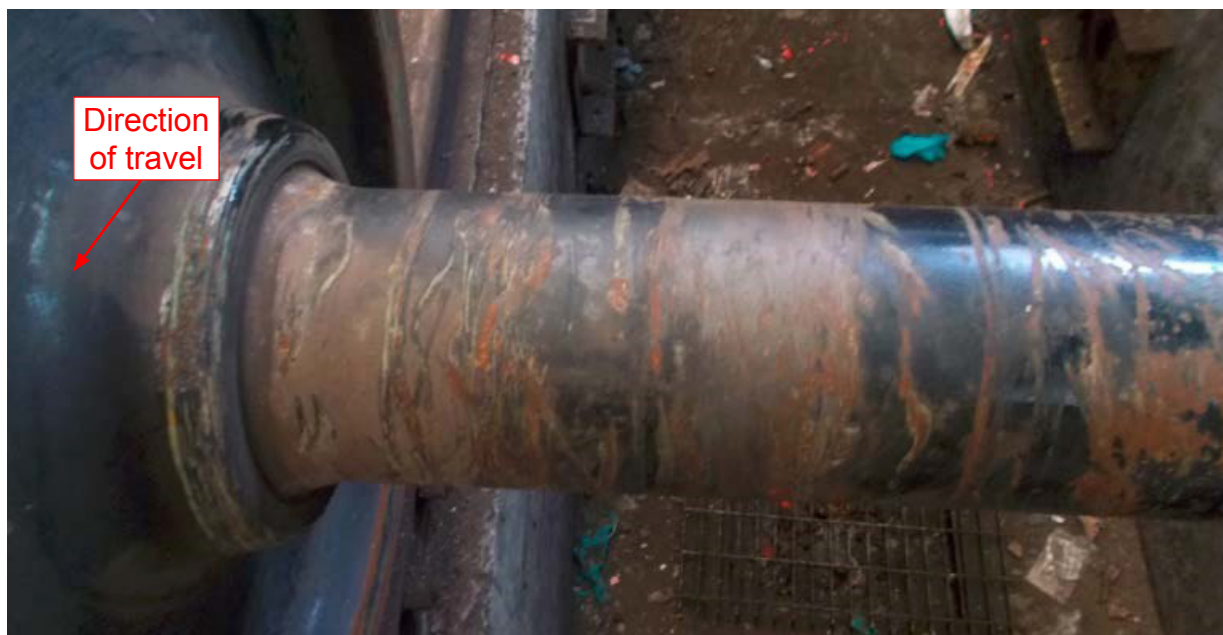
Figure D13: Evidence of rubbing contact adjacent to wheel position 5 (courtesy DB Cargo)
